ARL-SR-0383 • SEP 2017

Shoreline Erosion and Proposed Control at Experimental Facility 15–Spesutie Island

Weapons and Materials Research Directorate, ARL

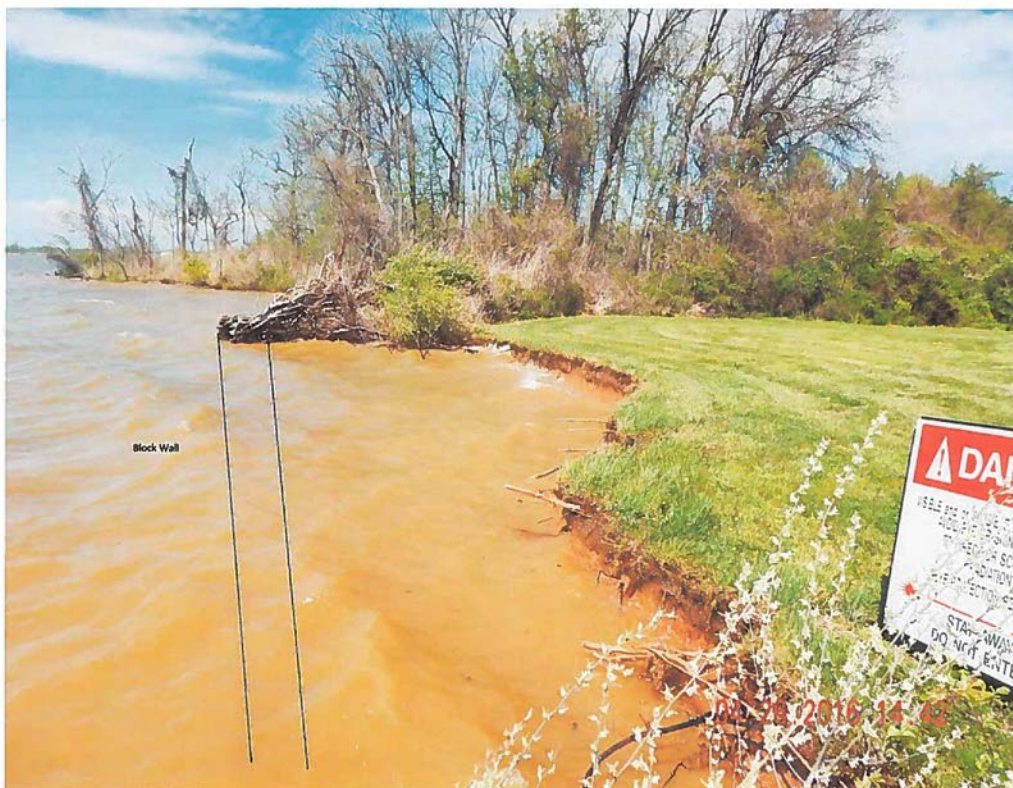
Fig. 2 Erosion of shoreline at EF 15, Spesutie Island, and (photo-enhanced) location of proposed block-wall placement

After noticing the effects of all of the aforementioned contributing factors, an initial plan was set in place to stop, or at least minimize, the erosion at the facility by way of a break wall constructed from concrete blocks (Fig. 1). The ARL Environmental Research Group (ERG) was called out to see firsthand what was taking place and to measure and assess the extent of damage to the shoreline. First and foremost, the ERG was required to submit a Record of Environmental Consideration (REC), APGR 200-1,² and also a site plan before any work was to be initiated. The REC (Fig. 1) is shown on the next page followed by a picture (Fig. 2) showing damage to the shoreline with the proposed placement of the break wall.

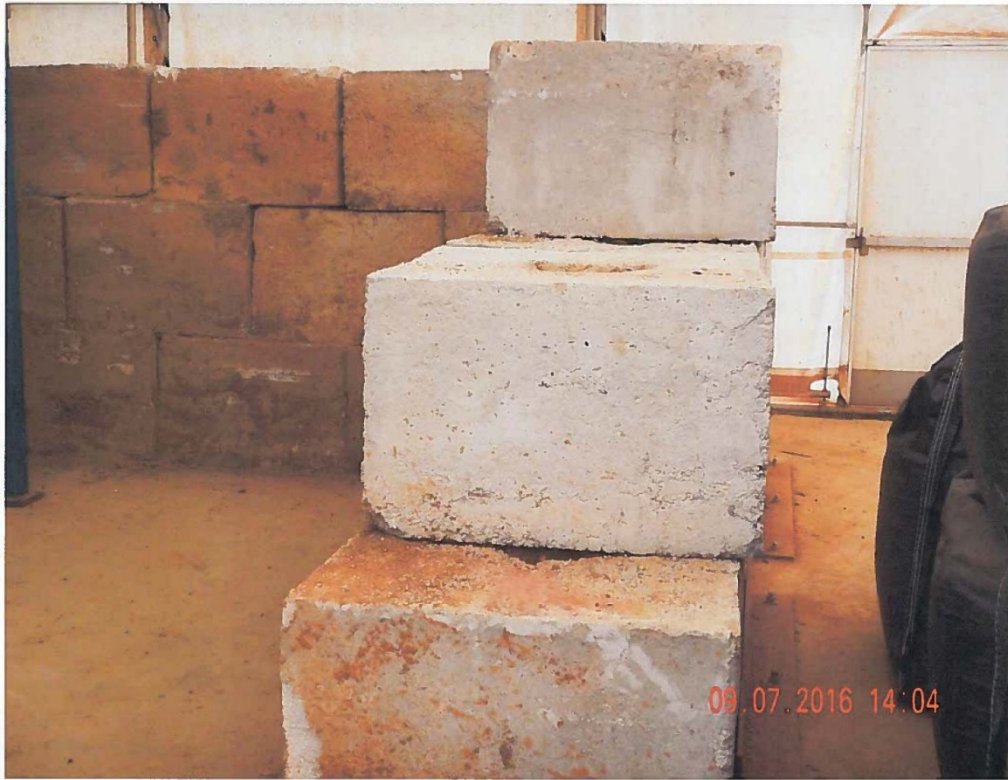
Fig. 3 Example of concrete blocks for EF 15 break wall

Proposed activity is to provide labor, materials and equipment to create a shoreline break-wall at EF-15. Over the past 3 years the EF-15 facility has lost approximately 15 feet of shoreline property and habitat due to wave action from the Spesutie Narrows. Proposed action is to place concrete blocks measuring 3' long by 3' wide by 2 foot tall approximately 10 feet from the current shoreline. The blocks will be stacked 2 high for a length not to exceed 100 feet. There will be 6 inch gaps between the blocks to allow water to flow through and prevent back wash issues. EF-15 is located on the west leg of Spesutie Island. Project will be ARL funded and executed. Please find attached pictures of erosion and proposed wall site.
